Investigation of Pink Staining on

Marble Sculpture at the J. Paul Getty Museum

by Allison Lewis and Monica Ganio

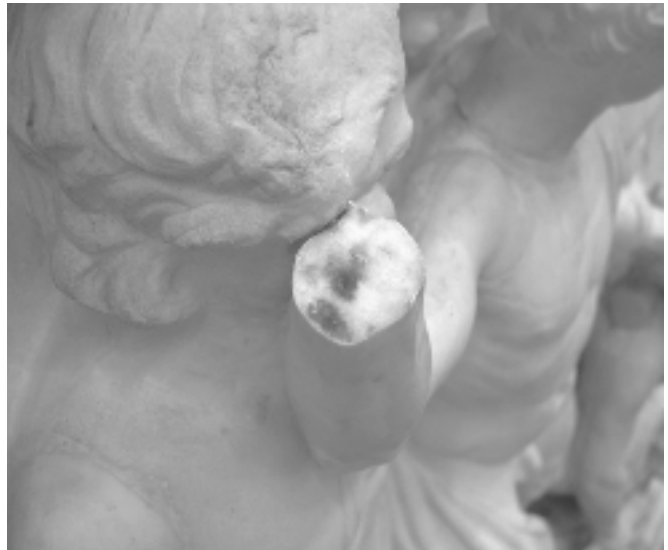
During the 2008 conservation of four marble sculptures in the antiquities collection at the J. Paul Getty Museum (JPGM), localized bright pink discoloration in association with a brownish, slightly rubbery adhesive was observed on join surfaces. (Figure 1) All four objects had been treated sometime in the 1970s with unknown materials, including undocumented adhesives.

Figure 1. Pink staining on the join surface of JPGM 78.AA.61.

While retreating the sculptures in 2008, JPGM conservators encountered pink discoloration already present on join surfaces and observed its active formation. Upon the introduction of deionized water and polar organic solvents, the pink material became very mobile, and in some cases bled to the exterior surface of the stone and newly applied fill material.

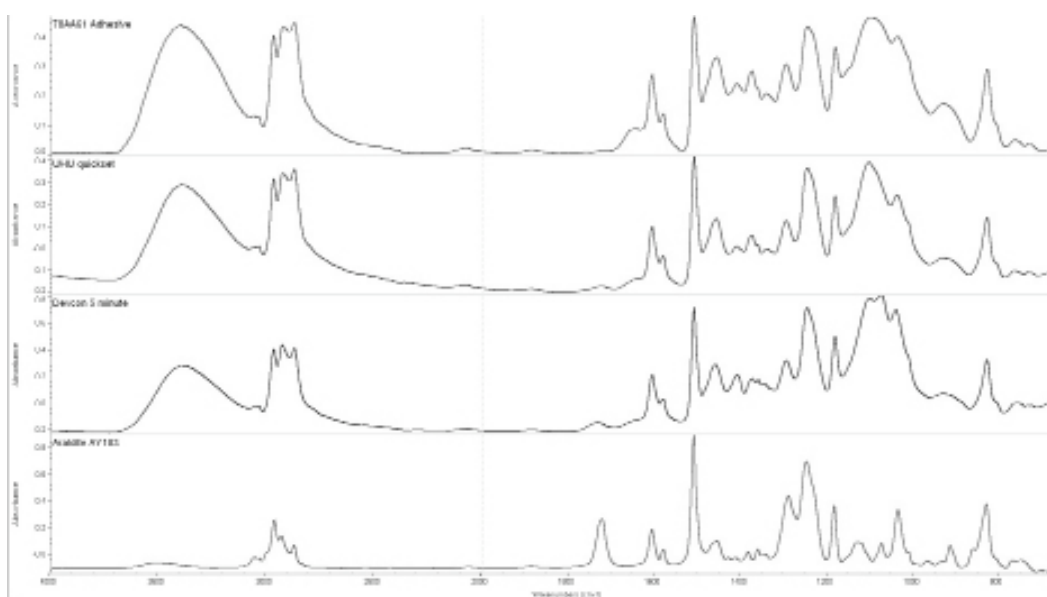
FT-IR confirmed that the adhesive associated with the pink discoloration is an epoxy and that the same epoxy was used on several of the marble sculptures. The analyses showed a very good match between the samples and UHU plus quickset and Devcon 5 minute epoxies from the 1988 GCI reference board, suggesting the use of a rapidly setting epoxy.

Figure 2. FT-IR spectra of:

pink-stained adhesive from
JPGM marble sculpture
78.AA.61

UHU plus quickset epoxy
(applied 1988)

Devcon 5 minute epoxy
(applied 1988)

and Araldite AY 103 epoxy
(applied 2009).

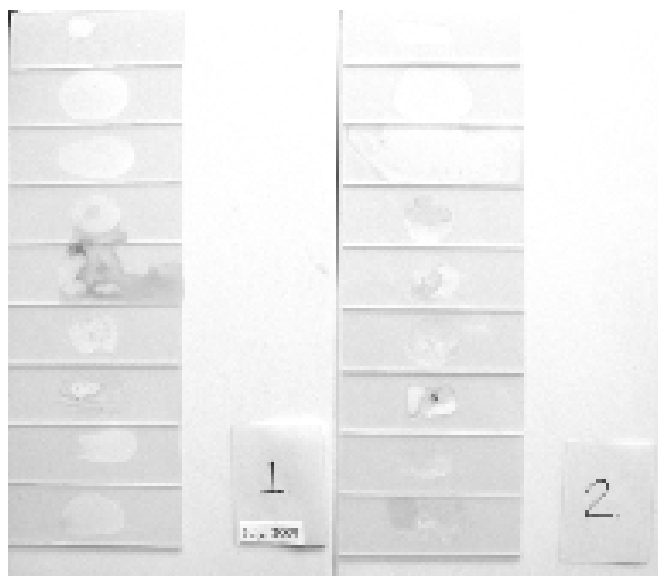
Pink staining developed in two locations on the experimental marble pieces over a period of four months. In both instances, pink discoloration appeared on the marble surface adjacent to new UHU plus quickset that had been cured at elevated relative humidity. On the board which had been

Figure 3. Experimental marble boards 1 (control) and 2 (cured at elevated relative humidity) four months after the application of UHU plus quickset epoxy. Faint pink discoloration formed on board 2, slide 3, the site of UHU plus quickset with excess hardener.

prepared at near 100% relative humidity, a faint pink halo appeared around the application of 1:3 binder: hardener (v: v) UHU plus quickset, the excess hardener formulation. No other pink staining appeared on any of the marble boards.
