THE REINSTALLATION OF AN 1830'S  
ZUBER SCENIC WALLPAPER  
AT THE  
MARTIN VAN BUREN NATIONAL HISTORIC SITE

BY JAMES HAMM \*

The removal, treatment, and reinstallation of a Zuber scenic wallpaper was carried out in phases over a period of eight years. In designing the reinstallation, considerations were given to environmental fluctuations, adhesive flexibility, reversibility, toxicity and stability, ease of handling and trimming, plus the appearance of moldings in proper relative relief to the wallpaper. The mounting system will allow future removal of the treated wallpaper without the use of water or solvents. Some problems encountered with the contraction of the large wallpaper panels were solved after discussion with the curator and project coordinator.

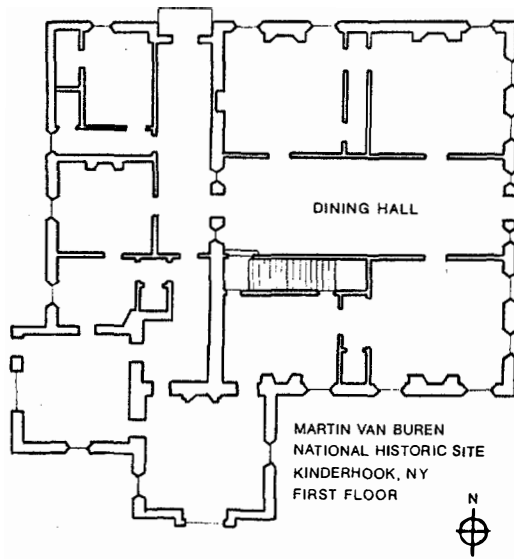
1. (Left) Floorplan of Lindenwald locating the 15' x 42' dining hall. The narrow outside wall faces east.

The Dining Hall proved in many ways to be a nearly ideal place for the display and ultimate preservation of a scenic wallpaper because of the large, mostly unbroken, wall space, and three "inside" walls. [See illustration #1.] The fourth wall, an "outside" wall, endured wide environmental changes and the wallpaper here was essentially unsalvageable. The opposite wall at the west end of the room had lost all of its paper for unknown reasons at some time earlier, except for a section of the balustrade dado hidden behind a 12" high baseboard molding in the stairway. It was decided to cover these two walls using a recent edition of the Zuber scenic paper. The balustrade dado panels (the original of which has been long out of production) were reproduced by Scalamandre, in New York City.

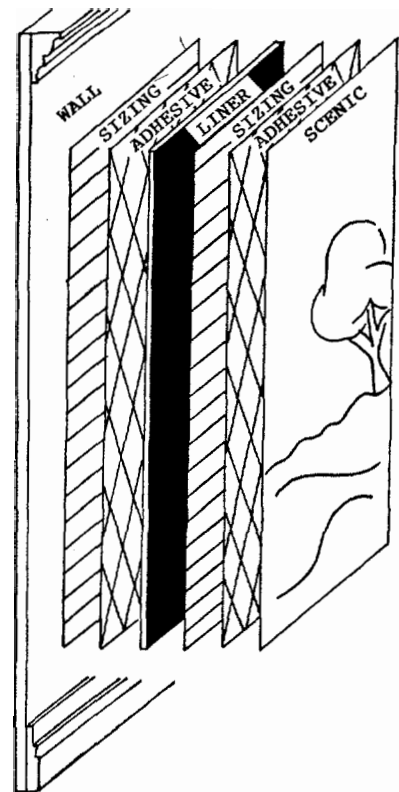
2. (Right) Schematic drawing of laminar mounting system.

We experimented with mounting mock-ups using various commercially available wallpaper adhesives, sizings, and liner papers, as well as discussing our requirements with several manufacturers' technical representatives and a professional paper hanger, Bob Kelly of Lee, Massachusetts. Eventually, we devised a system which met our requirements, at least on the small scale of 12" square mock-ups. It now remained for the system to be scaled up to room size. [See illustration #2]

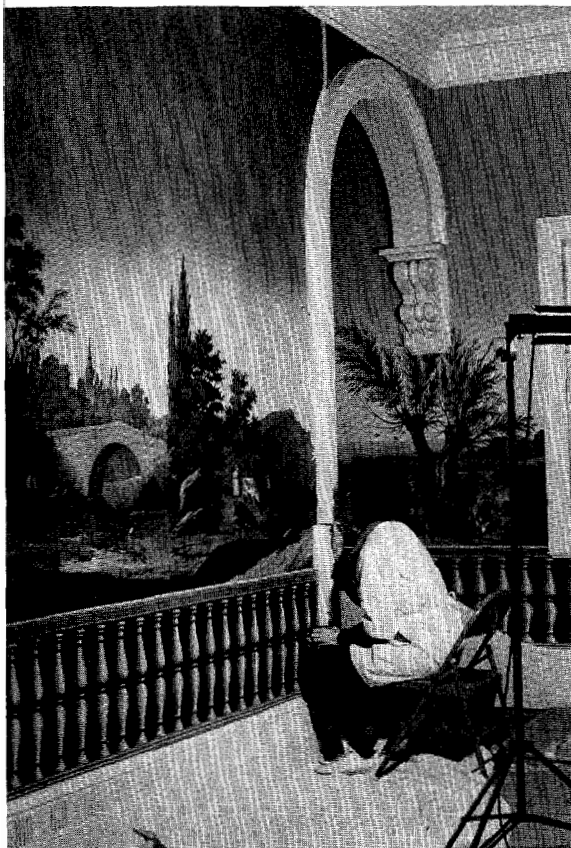
3. (Left) Painting the narrow, vertical insert on the south wall. Background shows portion of 1950's edition of the Zuber scenic on west wall.

Two vertical inserts were made, one each on the north and south walls, to compensate for this small shortfall. Full length "scraps" of the 1950's edition scenic were trimmed and turned face in, adhering them to the liner with Muralo 8060. The scenic design was continued with an exact pencil drawing, then reconstructed using the same inpainting palettes made up during the conservation treatment performed during 1980 and 1981, plus some additional colors. Several light spray coatings of 8% Acryloid B-72 resin in xylene and toluene [2:1] were applied to unify gloss and to match the adjacent panels better. [See illustration #3.]
