THE CHICAGO HISTORICAL SOCIETY FLOOD
Recovery Analysis Two Years Later

by Carol Turchan

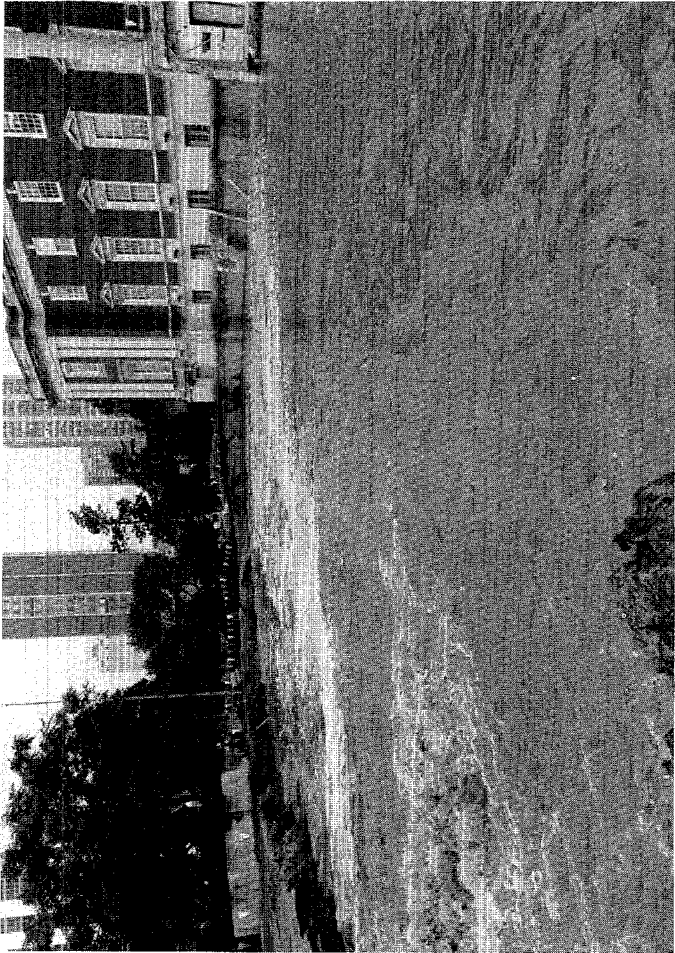
(Fig. 4) By 7 pm the water level was at 9 feet.

The library and museum staff viewed the scene soberly. Visualizing a potentially disastrous conclusion, they immediately set to work stopping up cracks and holes in the basement wall that backed up to the site rapidly filling with water. Some moved 600 framed paintings that remained in the basement storage vault to the floors above. For three hours the water continued to pour into the site. The level, and pressure on the foundation wall rose steadily. (Fig.4)

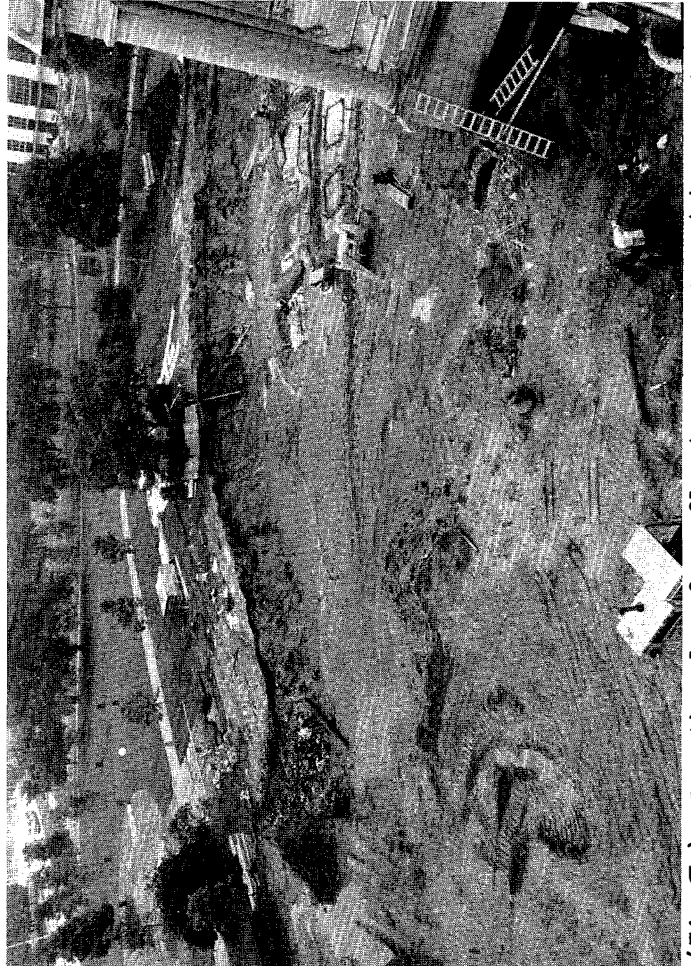
(Fig.5) Immediately after flood water entered basement.

The water tore through the basement corridors dragging with it empty picture frames, crates and other debris that lay in its path, as well as great quantities of sand and silt that it displaced beneath the building. Two staff members were trapped by the deluge. One dramatically rode the rush of water down a long corridor tangled in a huge picture frame, while the other managed to pull himself along pipes in the ceiling to a stairwell exit. Both narrowly escaped serious injury. In less than five minutes, by 7:55, the excavation had emptied the way a bathtub empties when the plug is pulled. The water, however, was all in the Society's basement. (Fig.5)

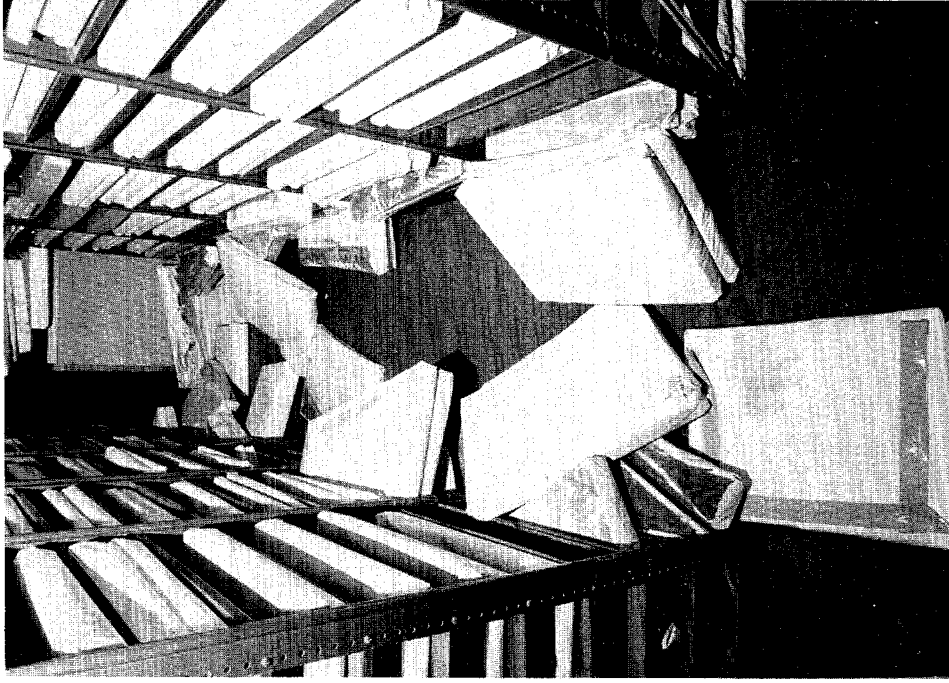
(Fig.6) Newspapers forced off shelves by flood water.

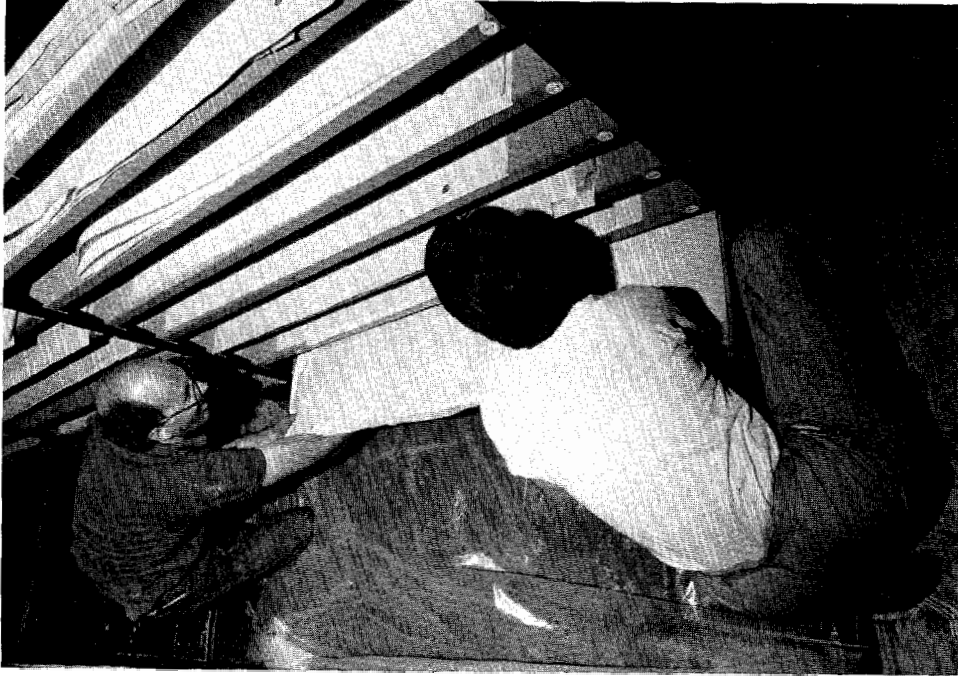
(Fig. 9)
Narrow spaces between compaction units.

Folders of drawings were gingerly removed from bottom shelves in the very narrow, three foot spaces between the movable units, and carried, with the aid of polyethylene sheeting, to tables nearby for the salvage work. The large, flexible 3' x 4' folders of slippery drawings are awkward to handle even under normal conditions. They had protected the drawings to some degree from the entry of water, sand and silt. Linen tape hinges at the fold edges became soggy and sticky when wet. The folders were discarded, but first documentation was torn from them and kept with related drawings. (Fig. 9, 10).

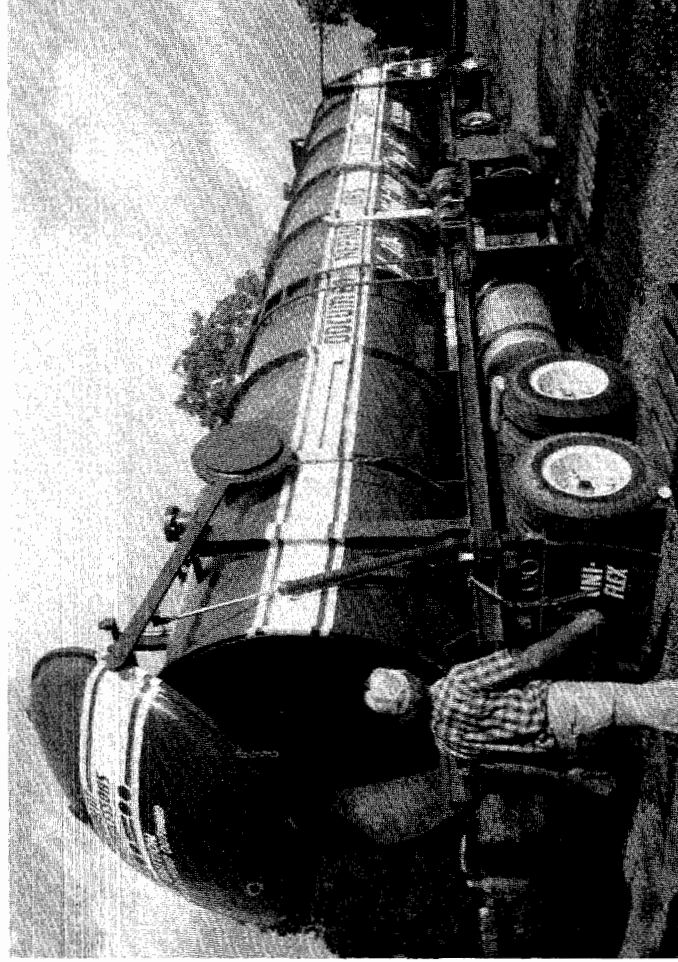
(Fig. 15) Document Reprocessors mobile freeze-drying chamber.

We selected Document Reprocessors based in San Francisco to do our freeze-drying. The company uses large, mobile vacuum chambers that are intended to be moved to the site of a disaster to dry water-damaged materials. (Fig. 15) Unfortunately for us, the unit that had been recently adapted to do freeze-drying, our chosen method, was located in Rochester, New York, and could not be routed elsewhere until the new equipment had proven itself, so Document Reprocessors transported our frozen paper collections 600 miles by freezer truck to Rochester.

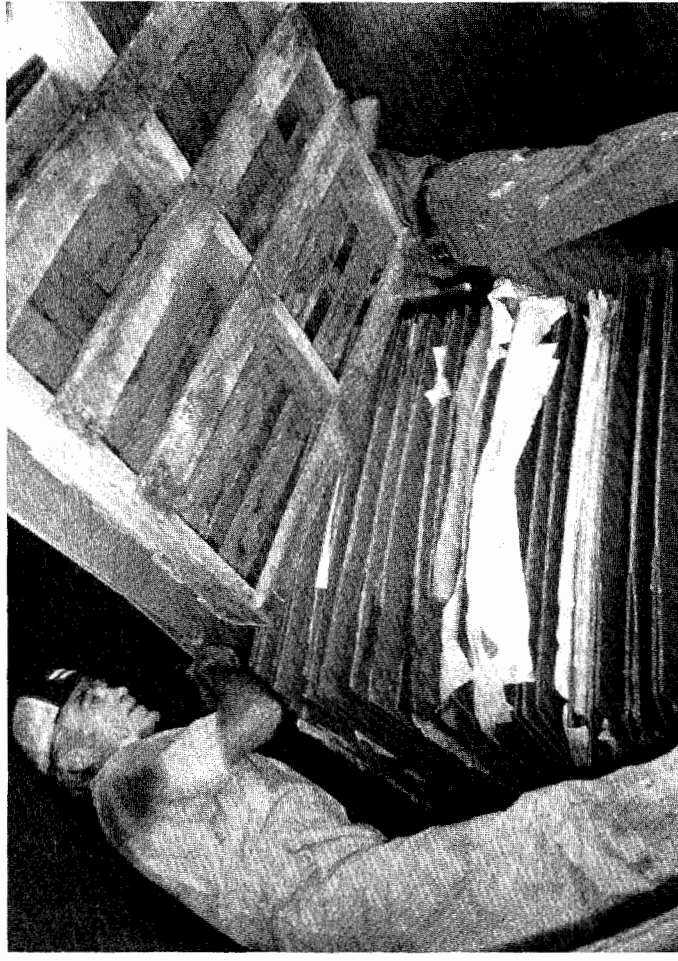
(Fig.16) Drawings being loaded into vacuum chamber.

Heat is introduced in Lundquist's system through a series of "platens" of copper tubing through which water and anti-freeze flow. The platens are layered between the boxes of books and packages of drawings to distribute the heat where it is needed. Drying time is dependent on several factors: the size and density of objects, degree of wetness, the size of the load (ours was approximately 650 cu. ft., a full chamber), and the temperature at which freeze-drying occurs. At higher temperatures
