## Wallpapers at Winterthur: Seeing Them in a “New Light”

Over a four-year period, in conjunction with the installation of new lighting in period rooms, fourteen early wallpapers received conservation treatment.<sup>1</sup> The goal was not only to stabilize but also to minimize the appearance of damage, since the improved lighting system would make the wallpapers more visible. In most cases, traditional flat paper conservation techniques were appropriated for large-scale treatment in situ. This article will focus on three rooms as case studies illustrating particular challenges and solutions.

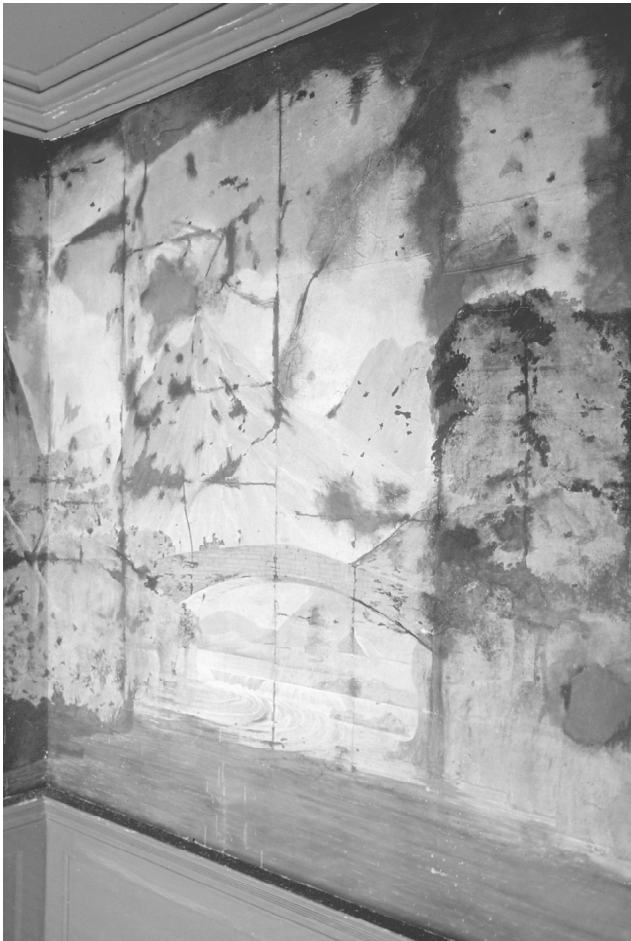
Fig. 1. Billiard room south alcove, before treatment: ultraviolet light

The south alcove of the billiard room at Winterthur displays a scenic painting on paper executed between 1800 and 1810 by Michel Felice Corne, an itinerant Italian American painter. The romanticized landscape is painted in a tough, glue-bound or casein paint on panels of wove paper. It was removed from the Lindall-Barnard-Andrews House in Salem, Massachusetts, and restored and installed at Winterthur by Guertler Studios of New York in the 1960s. Previous restorations had overpainted abrasions and even eliminated or extended design features to create transitions to adjacent areas of reconstruction. An ultraviolet light view reveals the extent of the overpaint, shown as dark absorbing areas (fig. 1). The restorers had extended the tree line and covered the slope of a mountain at the right. The paper

was covered with a discolored varnish, imparting a mottled, yellow tone. Examinations by long wave ultraviolet light and FTIR characterized the coating as a synthetic alkyd resin.<sup>2</sup>

The assistance of paintings conservator Mark Bockrath was sought because the treatment of this wallpaper involved many painting conservation issues. After extensive testing it was determined that removal of the varnish and overpaint would reveal the artist's original brushwork and scenic details. Both materials were readily soluble in a solution of ten parts water, ten parts ethanol, ten parts acetone, and three parts benzyl alcohol, applied with cotton swabs rolled over the surface. The benzyl alcohol component was the active solvent, while the ethanol and acetone allowed both greater wetting of the surface and quicker evaporation. A portable multi-arm fume extractor effectively reduced solvent fumes in the room.<sup>4</sup> As the overpaint and discolored varnish were removed, the scene regained depth and dimension.

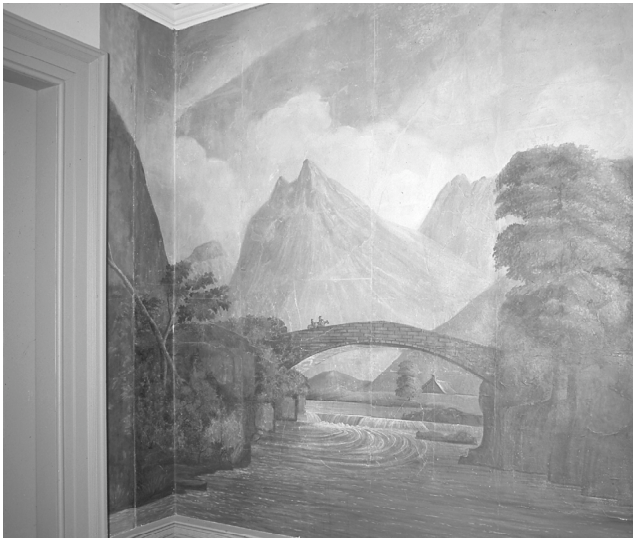
Fig. 2. Billiard room south alcove, before treatment

After cleaning the old inserts were markedly ill matched to the original paint layer. In the interest of time, the old inserts were modified and kept rather than replaced with new fills. Since they often extended beyond the loss edges onto the original, excess fill paper was pared down with a scalpel. Lifting edges were adhered with wheat starch paste and dried with a tacking iron over polyester web and blotter.

Cracks and gaps along the pared inserts were filled with vinyl polymer spackle. The spackle was easy to apply and texturize and will remain water-soluble throughout its life for easy reversibility. The fills were inpainted with acrylics to mimic the opaque paint surface of the original. The slope of the mountain revealed during cleaning along the right center edge was continued onto the plaster reconstruction. Other reconstructed sections along the perimeter were adjusted using acrylics (figs. 2–3).

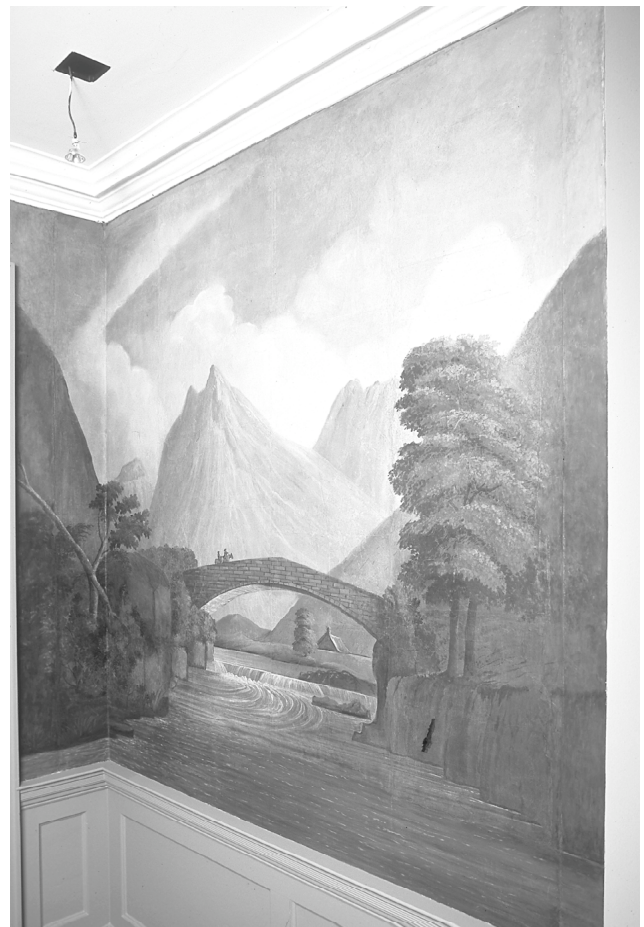
Fig. 3. Billiard room south alcove, after treatment

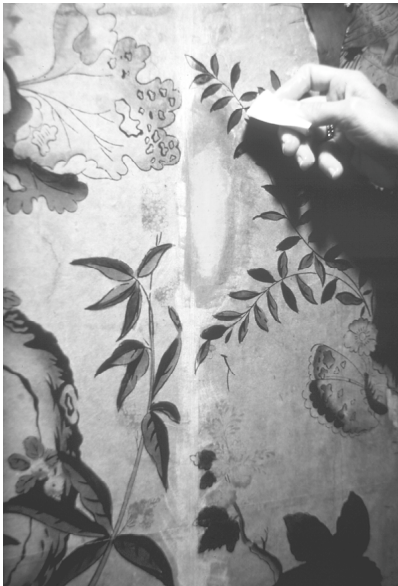
Fig. 4. Blackwell vestibule, during treatment: removing overpaint using dense foam cosmetic sponges

After attempts to tone the overpaint proved unsatisfactory, the decision was made to fill the losses with new, toned inserts. The water-soluble overpaint was reduced using cosmetic sponges.<sup>8</sup> The sponge imparted very little moisture to the wall, and there was virtually no abrasion to the plain paper background from this dense foam (fig. 4). The components of the foam material were characterized using XRF and FTIR and determined to be inert.<sup>9</sup>

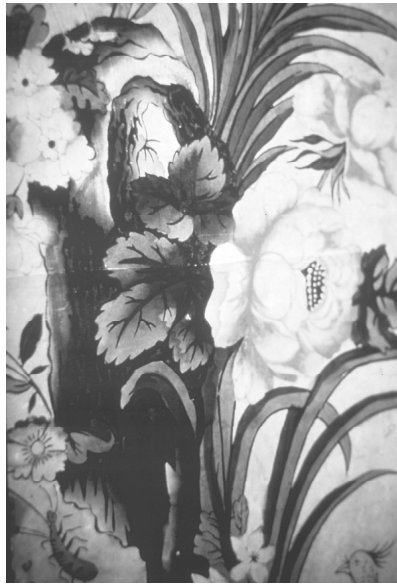
Fig. 5. Blackwell vestibule, during treatment: water stain in flower petal

Disfiguring water stains were reduced with controlled moisture. The mist from an ultrasonic humidifier fitted with a Nalgene tube was directed at the stain. A line of moisture was applied to the tideline and then feathered out beyond it, maintaining soft edges. The misted areas were blotted with chromatography paper to absorb discoloration. After two or three repetitions, a final broad

mist was used to diffuse any hard edges that might have formed. The area was dried with a hair dryer on the cool setting (figs. 5–8). This treatment was changed somewhat for areas of reconstruction with a painted paper background. Since direct contact could lift off the fragile paint layer, the stains were misted and dried with the hair dryer, repeating the process three to four times. This method diffused the stains rather than removing any discoloration.

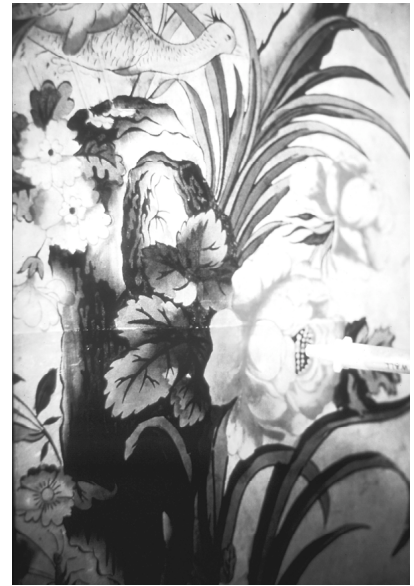
Fig. 6. Blackwell vestibule, during treatment: wetting water stain with ultrasonic mist

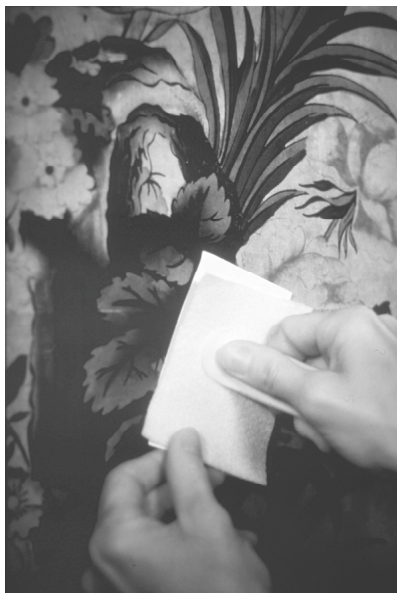
Fig. 7. Blackwell vestibule, during treatment: blotting water stain with chromatography paper

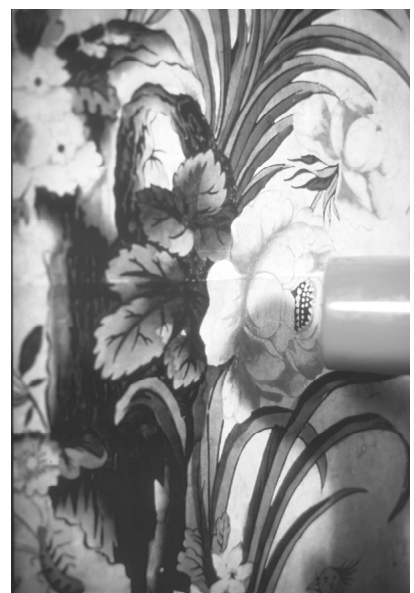
Fig. 8. Blackwell vestibule, during treatment: drying treated area with cool hair dryer.

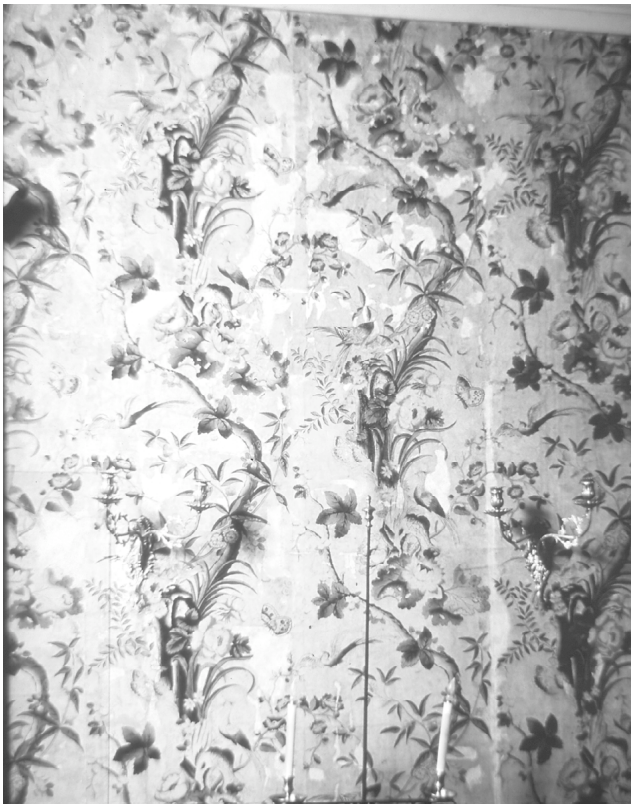
Fig. 9. Blackwell vestibule south wall, before treatment

Losses were filled with a modern laid paper toned with acrylic paint. Alternating washes of warm ochre and cool violet provided a range of subtle tones which could be matched to each loss. The inserts were pricked out using a polyester tracing and adhered to the lining paper with wheat starch paste. The wallpaper along the edges of a closet door was brittle and vulnerable to loss. To protect the edges during continued use of the closet, feathered strips of toned Japanese paper were adhered to barely overlap the wallpaper surface then wrap around the side edge of the door.

Inpainting proceeded under a boom equipped with the new halogen bulbs and a dimmer switch, to duplicate the color temperature and angle of light expected once the lighting project was complete. Traces of old overpaint which could not be safely removed were toned with dry pigments to blend with the support. Interrupted design elements were connected using watercolors.

The museum and historic light fixtures were rewired to bring everything up to electrical code. This required removing sections of wallpaper around junction boxes to provide access for electricians. Once plastered, the wallpaper was replaced, inserted, and inpainted. The last step was to brush down the walls gently, collecting any loose pigment dust with a HEPA filter vacuum. In all rooms Plexiglas protects bottom panels of wallpaper along the tour route. After treatment the disfiguring stains and overpaint no longer interrupt the design, and the flowing pattern can again be appreciated (figs. 9–10).

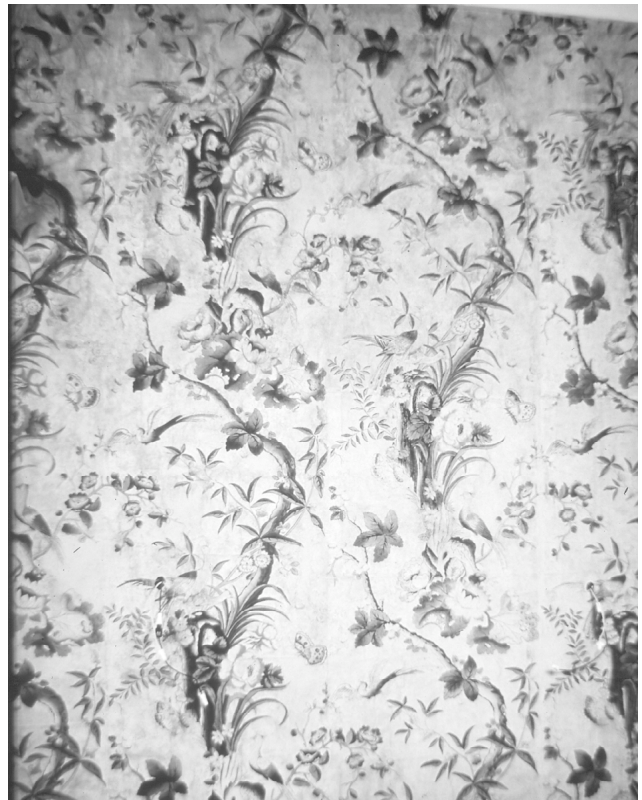
Fig. 10. Blackwell vestibule south wall, after treatment

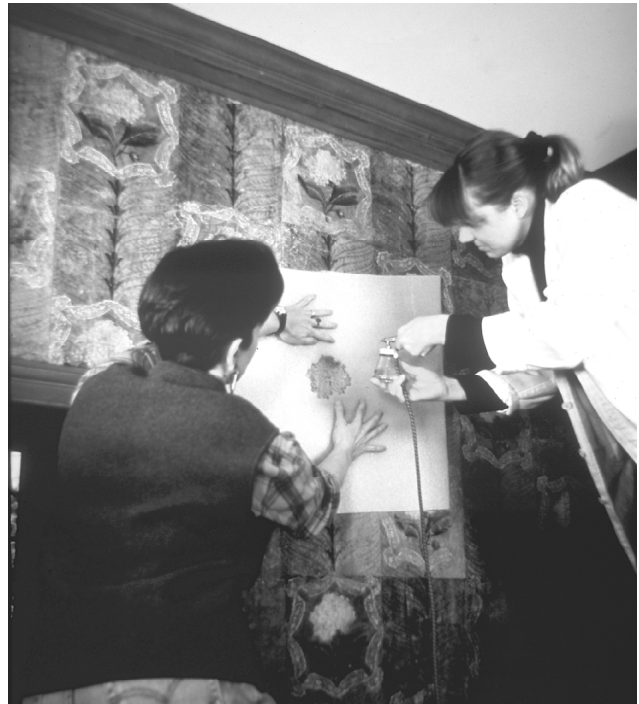
Fig. 11. Cecil Hall, during treatment: applying gelatin consolidant using an airbrush

After surface cleaning with vulcanized rubber sponges, lifting areas were readhered with wheat starch paste and methyl cellulose. Since the wallpaper stained easily, tabs of thin, stiff blotter were used to deliver a drier paste mixture. The repeating floral motifs had significant loss and what remained was a powdery layer with islands of heavier flakes, both very insecure. A room diagram detailing each wallpaper panel and design repeat was used to chart various adhesives and methods tested for consolidation. Spraying with an airbrush was found to be safe, effective, and efficient. An Ethafoam mask was bevel-cut in the flower shape and held against the wall to shield surrounding wallpaper. The texture of Ethafoam helped to keep overspray from dripping and the bevel helped prevent any spray from seeping behind the mask edges. A one percent gelatin solution in water and ethanol was sprayed in a sweeping motion until the surface appeared well-saturated (fig. 11). One application was sufficient to consolidate powdery areas while two applications were needed in areas of heavier flaking. Holding the Ethafoam mask loosely against the wall helped to prevent hard wet/dry boundaries. Since the wallpaper stained easily, it was still necessary to feather the sprayed area with ethanol applied by brush. Drying was hastened with a hair dryer on the cool setting.

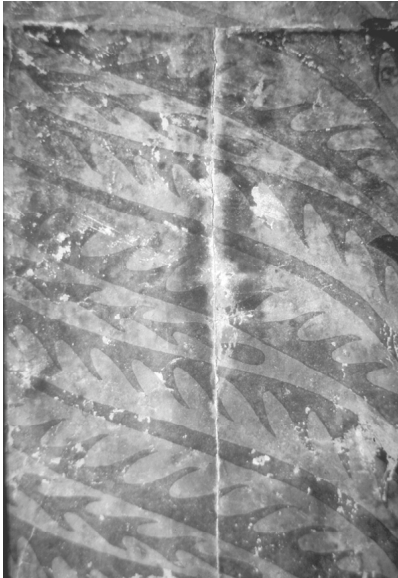
Fig. 12.. Cecil Hall, detail: stained area before treatment

Once the paint was consolidated, stain reduction could safely begin. Attempts to diffuse the water stains using ultrasonic mist were ineffective on these older stains. In addition the thick paint layers began to crack and cup from the repeated cycles of wetting and drying. Further testing indicated painting a line of water onto a blotter, placing it in contact with the stain, and drying it with a warm tacking iron could pull out discoloration. Significant discoloration was removed after successive applications of this technique, and no paint cupping resulted when limited to four applications. However, a superficial tideline formed in the pigment layer, which would require the use of the ultrasonic mist to diffuse. Since the paint layer could not tolerate this procedure, a line of water was painted onto the blotter; then the entire blotter was sprayed out with 80:20 water:ethanol, placed against the stain, and dried with the tacking iron. This avoided any tideline formation and thus any need for further manipulation.

Dry pigments and crumbled pastels were applied with rubber tipped "paint erasers" and foam-tipped stencil tools. Dry media was also used to tone old overpaint which could not be removed safely by aqueous methods. Areas of loss and abrasion were isolated with methyl cellulose prior to inpainting with gouache. The cosmetic work on this wallpaper proceeded keeping in mind Mr. du Pont's willingness to accept evidence of age and wear. Rather than recreate design elements that had been lost, dry media was used to tone the losses to blend with the blue ground color. This approach allowed the design elements to come forward and a beautifully rhythmic pattern to re-emerge (figs. 12–13).

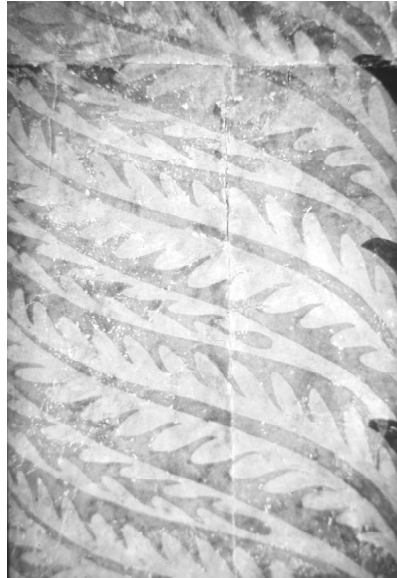
Fig. 13. Cecil Hall, detail: stained area after treatment

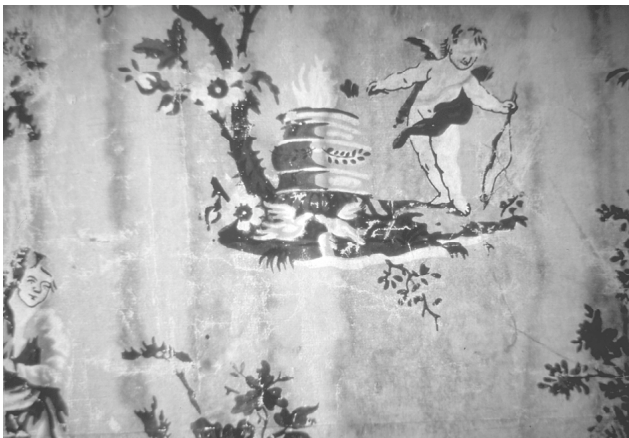
At the end of a work day, seven months into the project, the staff was alerted to a major water leak in the collection. A sprinkler line that was moved to accommodate the new lighting tracks failed, and an estimated four hundred gallons of water spewed from the ceiling. The water drained into the room below and into an adjacent stair hall, staining two different French block-printed wallpapers. Water also trickled down into Port Royal entrance hall, with its hand-painted Chinese wallpaper.

Fig. 14. Centreville stair hall, detail: after water emergency, before treatment

A less invasive approach was used on one of the French block-printed wallpapers, where recent water damage was interspersed with older water stains. The stains were first misted with an ultrasonic humidifier to soften the edges of

the tidelines. Then small sections of these panels were sprayed with deionized water in an attempt to diffuse *all* discoloration in the paper support in an even manner, without overcleaning any one spot. These sprayed areas were allowed to dry naturally in ambient air before compensation using pastels and dry pigments (figs. 14–15).

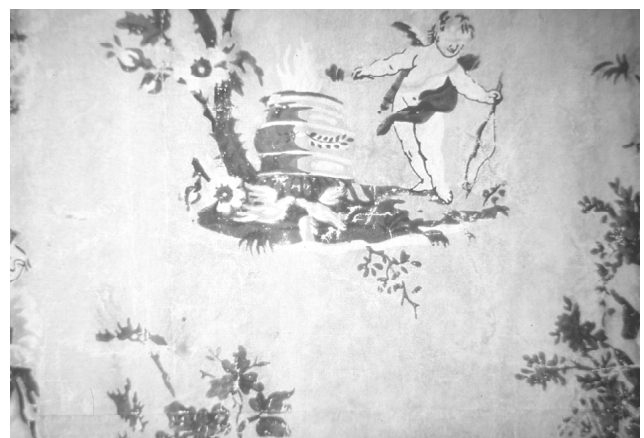
Fig. 15. Centreville stair hall, detail: after treatment
