## Paper, Pins, and Preservation: The Evolution of Wallpaper Conservation in a “Ruin” Environment

Presented at the Book and Paper Group Session, AIC’s 43rd Annual Meeting, May 13–16, 2015, Miami, Florida

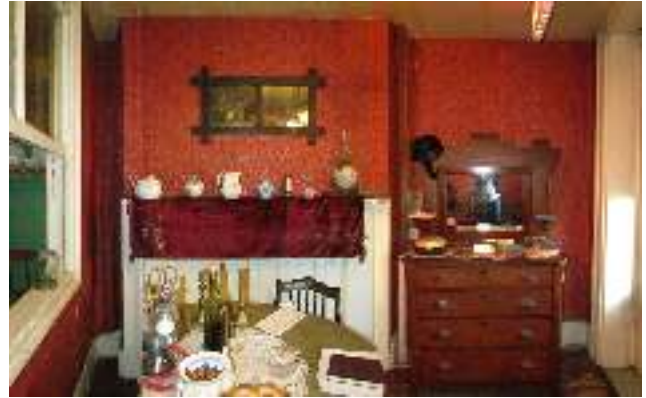
The museum classifies their apartments into two different categories, “restored” and “preserved.” Restored apartments are those which have been restored or reconstructed to a specific time period in the building’s history and are used as interpretive spaces. These apartments tell the story of actual residents of 97 Orchard Street using information gathered through historic research and family histories. Restoration treatments included new plasterwork and sheet rock, skim coats of plaster over historic finishes, painted finishes, and new wallpaper (fig. 1).

Fig. 1. Parlor of the “restored” Rogarshevsky apartment.

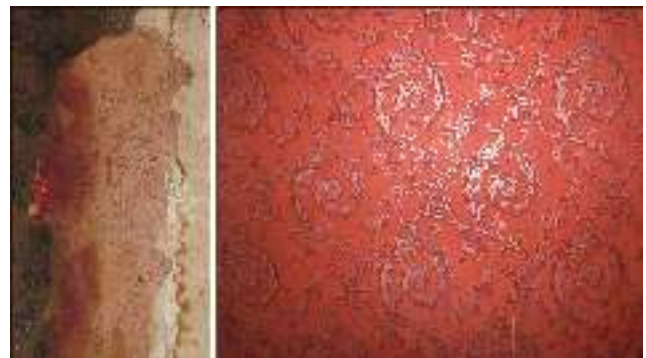
Ms. Snyder and the museum worked with wallpaper company Scalamandre, who provided their services pro-bono, to recreate some of the papers found during the analysis. The floral paper used in the Gumpertz parlor is a reproduction of the earliest wallpaper discovered in the museum. The red wallpaper used in the Rogarshevsky parlor is the 14th layer found in Apartment 11 (fig. 2). Based upon the wallpaper’s location within the stratigraphy of the layers, and the color and style of the wallpaper pattern, museum curators determined that this paper most likely dated to circa 1910, when the Rogarshevsky family would have been living in the building.

Fig. 2. Historic wallpaper on the left was recreated for the Rogarshevsky parlor (right).

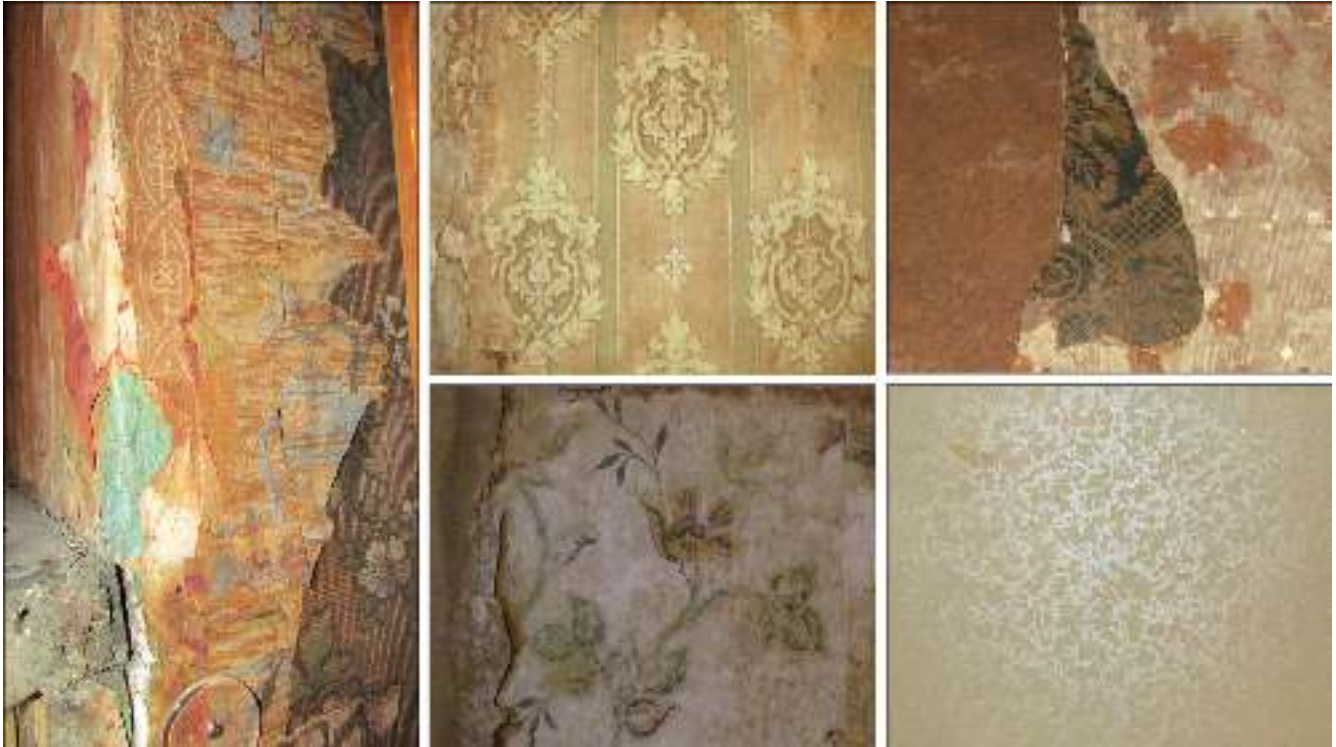
Wallpaper was a popular interior finish for the working poor as can be seen in the majority of the apartments at the Tenement Museum where there is a wide array of patterns including Asian-inspired designs, abstracts, florals, brocades, and stripes (fig. 3). Borders, running around the perimeter of rooms, are found in both floral and geometric patterns.

Fig. 3. Examples of wallpapers found within the LESTM apartments.

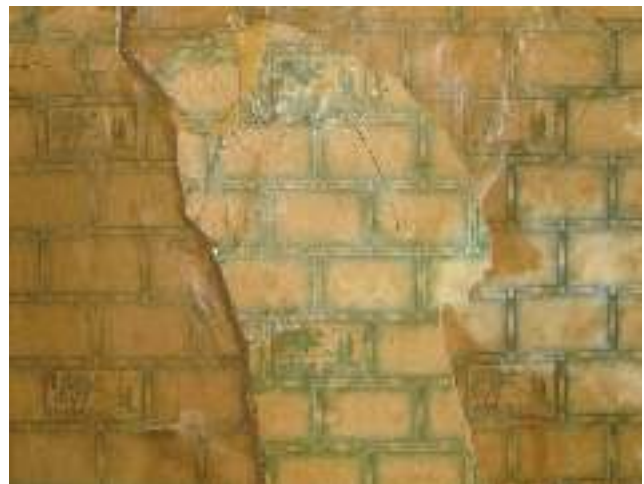
The Tenement Museum also has examples of sanitary papers. The late 19th century saw a great rise in sanitary concerns and wallpapers were frowned upon as decoration because they could not be cleaned. Wallpapers accumulated dirt, soot, and grease, and were thought by some to harbor insects and disease. Sanitary papers were seen as the answer to this problem, having a coating of varnish which allowed them to be washable. An 1887 article in the *Journal of Decorative Arts* entitled “The Homes of the Lower Classes; How to Make Them Sweet, Clean, and Beautiful,” stressed the use of this “economical and hard wearing” paper for “poorer households.” The walls of the kitchen in Apartment 11 were finished with at least two layers of sanitary paper. The design on this paper is one that was popular for many sanitary papers, which is in imitation of another material known for its sanitary properties—ceramic tiles (fig. 4).

Fig. 4. Washable “sanitary” paper found in the kitchen of Apartment 11.

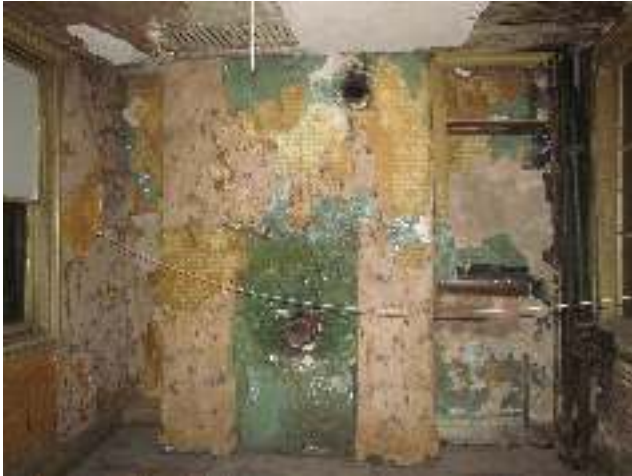
Fig. 5. “Preserved” kitchen of Apartment 11.

These historic wallpapers are all found at the Tenement Museum, in what they call a “preserved” apartment. The preserved apartments are those spaces which have been stabilized in their as-found condition and presented as “ruins” (fig. 5). These apartments endured over fifty years of water infiltration, uncontrolled fluctuations in temperature and humidity, and general neglect. Many of the papers in these apartments are in poor condition. They are stained, torn, and sagging. Additionally, these apartments also exhibit substrate conditions which greatly affect the historic paper, including exposed lath, peeling paint, and cracked, bulging, and detached plaster.

Analysis of the historic wallpapers found them to be pigmented Kraft-based papers with starch and glue paste adhesives. So, in addition to the damages caused by fluctuations in temperature and relative humidity, exposure to ultraviolet light, and failures of the substrate, these papers are also affected by the oxidation of the acidic wood pulp paper which caused the paper to darken, become brittle, and lose strength over time.

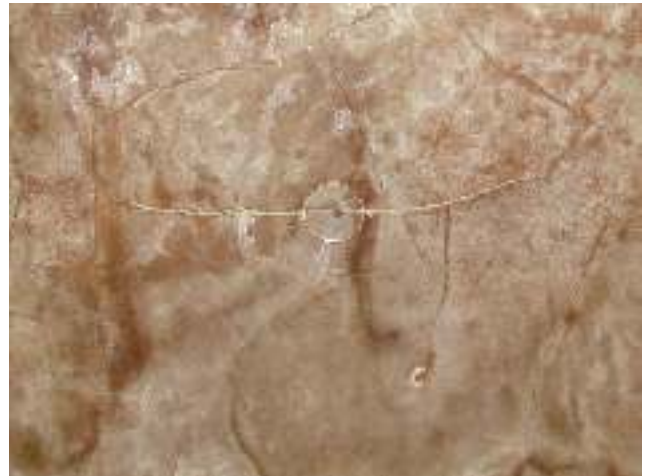
If the pins were carefully placed at the edge or along a tear, it was possible to re-adhere the wallpaper without puncturing it. Once installed, the clear pins do not block the pattern of the wallpaper and are often difficult to discern when viewed from a short distance from the wall.

The pinning treatment, however, also had its drawbacks. While an effort was made to place the pins at an edge of the paper in order to not perforate it, this was only successful if all of the paper edges are aligned. Due to the manner in which the wallpapers have torn, the edge of the top paper is often stepped back from the layers below.

Fig. 6. A pin placed along a tear to prevent puncturing the wallpaper.

In an effort to avoid the creation of additional stains caused by the adhesives on some wallpapers, buttons or pins were also used to re-attach the loose paper to the plaster walls. The pins are clear acrylic, 1/16-inch thick, in a variety of shapes and sizes with edges sanded smooth. They were installed with small stainless steel brads inserted through a pre-drilled hole in the button and gently hammered into the plaster (fig. 6). Rectangular pins were generally used for securing long tears; large disks for joining multiple tears; and small disks for small adhesion areas.

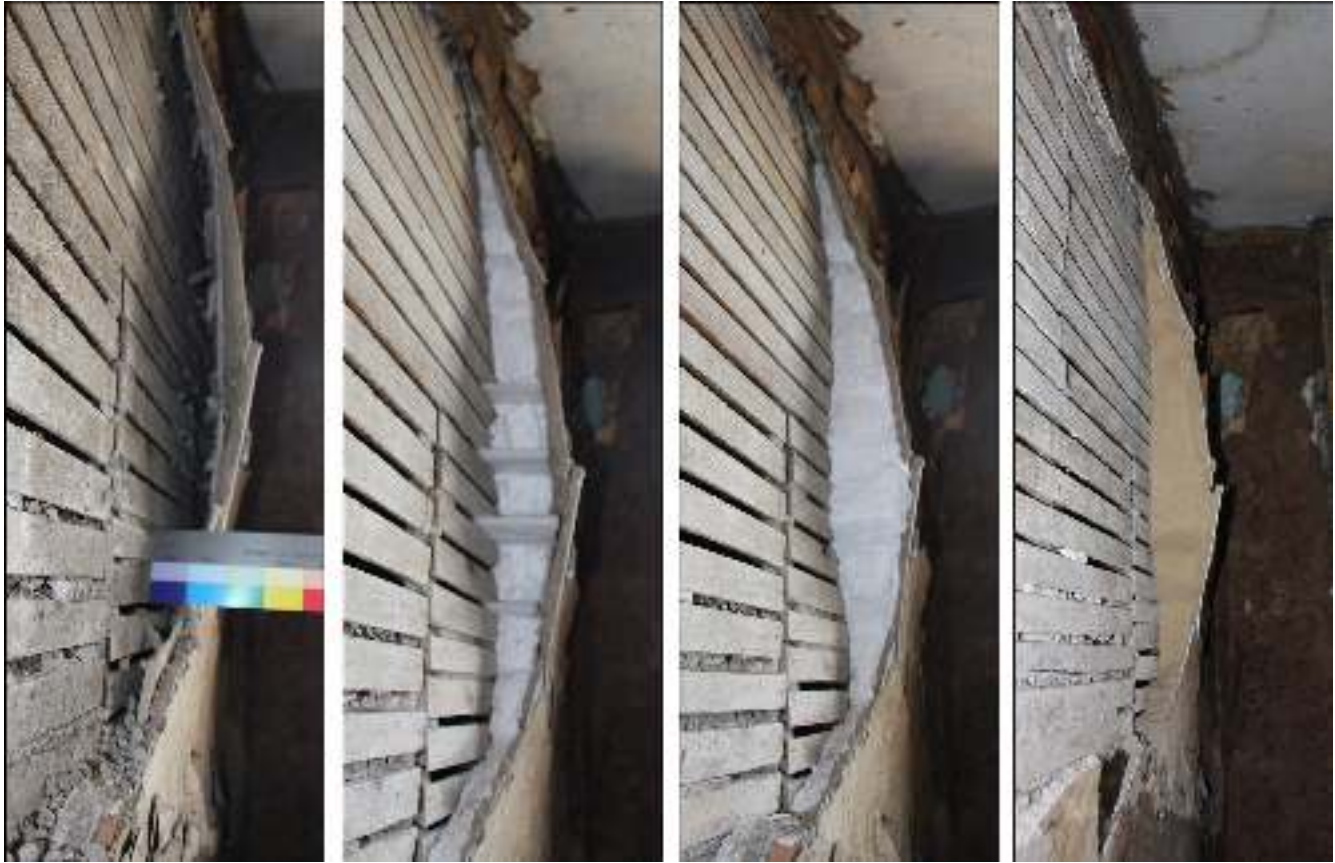
As the loss of the substrate, either paint or plaster, has an effect on the paper finishes, these elements have also had to be addressed. In several apartments, multiple layers of wallpaper have been applied directly over oil-based finishes which themselves have been painted over water-soluble distemper paints. High humidity and water infiltration had caused the distemper paints to fail. As the loss of paint leads to additional loss of paper, stabilizing the paint had to be part of the wallpaper stabilization.

Fig. 7. Stabilization of the plaster substrate to prevent additional wallpaper loss.

Flaking paint was stabilized using a 10% solution of Aquazol 200 in water applied with a natural bristle brush. Working in small sections, three applications of the Aquazol 200 solution were applied and then using a sheet of silicone paper against the surface of the paint, slight pressure was applied to the area. Larger paint chips that were completely loose from the plaster but which remained in place were re-adhered with an application of Jade R adhesive to the back of the sample and reset using tweezers. Once a smooth, stable

surface was achieved, the wallpaper was re-secured to the substrate using pins and Jade R adhesive where applicable.

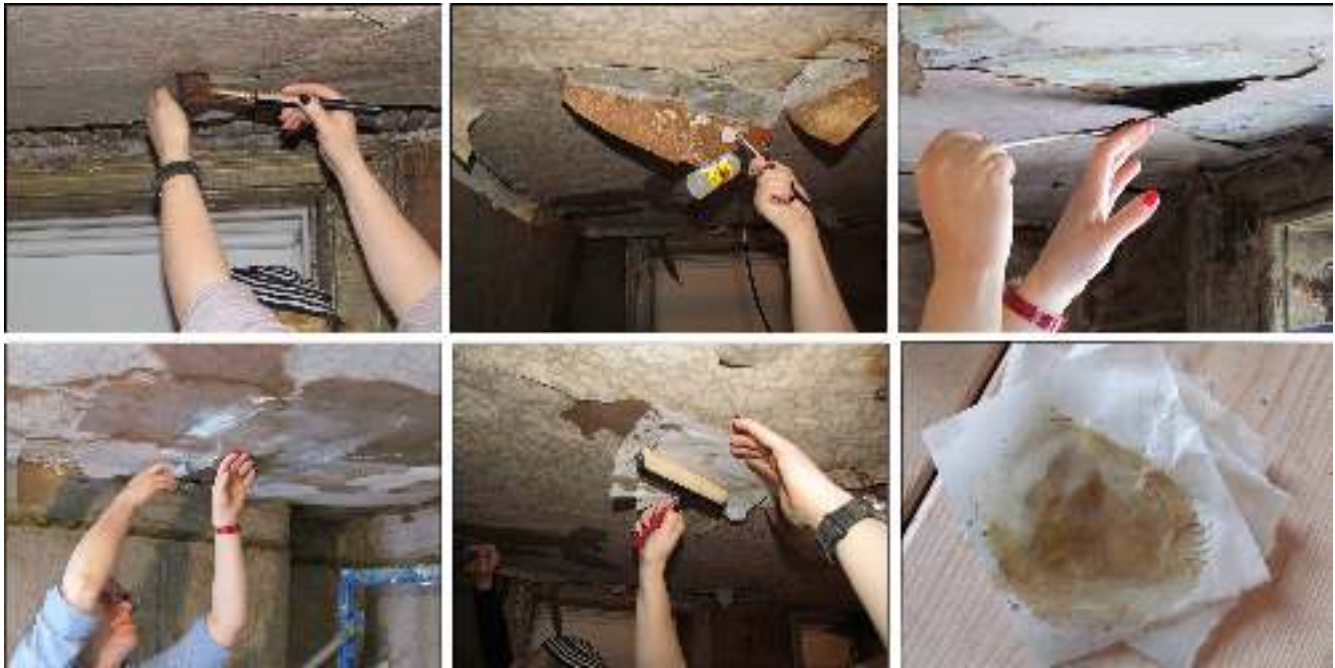
Fig. 8. Process of wallpaper stabilization using Tri-funori includes cleaning, consolidating, re-adhering, saturating, flattening, and cleaning.

A side benefit of the re-adhesion process was that the funori and tissue application also cleaned the wallpapers, many of which were heavily stained from water damage (fig. 8).

Prior to conserving the wallpaper, the backs of all of the detached papers were cleaned using a soft natural bristle brush. Three coats of funori were then spray-applied to the exposed distemper paints on the plaster. Over time these water soluble paints had become powdery and friable.

After the distemper paints had been consolidated, pieces of hanging paper were re-attached. Using natural bristle brushes, the funori/sturgeon glue mixture was applied to the exposed plaster and the back of the wallpaper which was then gently pushed back flat against the plaster. If the papers were extremely brittle, the surface was gently misted to soften it enough so that it would not break when returned to its original position. A second coat of the funori mixture was applied to the face of the wallpaper over a small square of Japanese tissue paper. For larger sections of detached wallpaper, an additional application of the mixture was injected behind the wallpaper to saturate it. Once the entire piece of failed wallpaper was re-adhered to the substrate, a wallpaper seam roller was rolled across the surface to remove any air pockets or creases. After the wallpaper was secured, the tissue was removed, taking care not to disrupt the bond between the wallpaper and substrate.
