# A new conservation lining for historic wallpapers

Philip Meredith, Mark Sandiford, Philippa Mapes

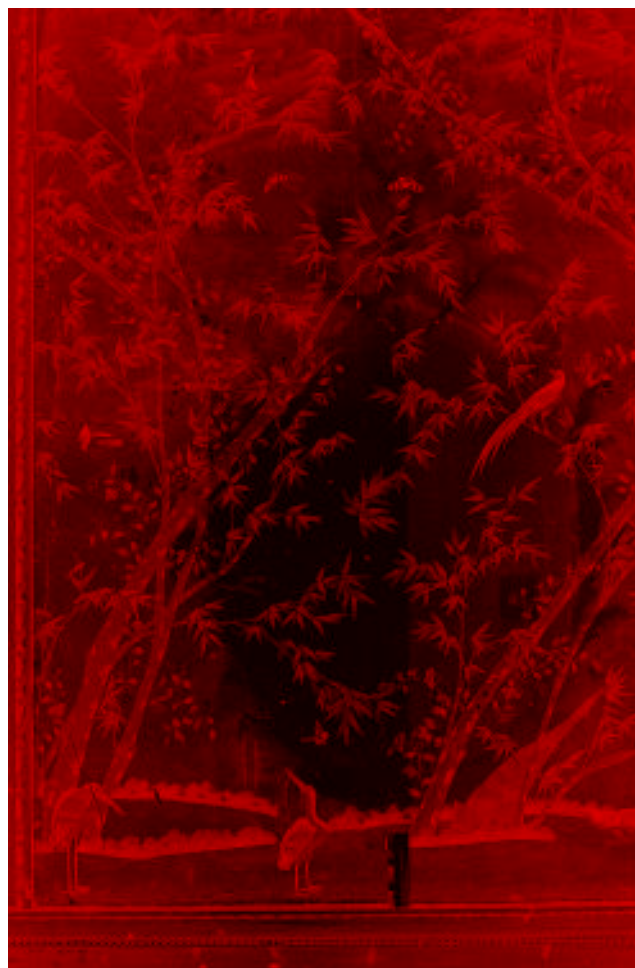
1. Chinese export wallpaper, mid. nineteenth century. Before removal during initial mechanical surface cleaning. Showing discolouration around pier glass.

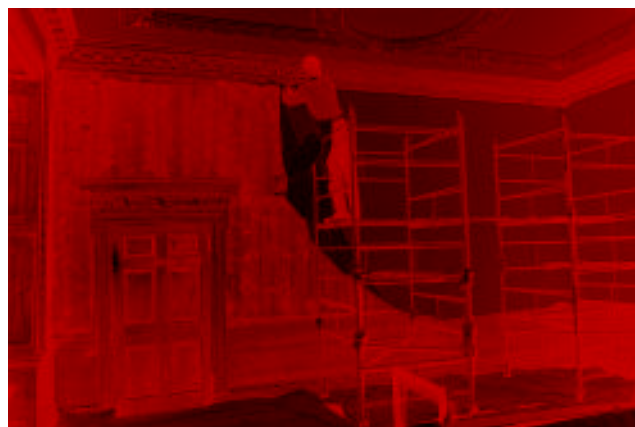
2. Hanging the polyester textile. Showing the wall surface constructed of wooden planking.

An alternative textile that is light, strong, and chemically and physically inert would correct the inherent weaknesses of the canvas. Woven polyester fulfils these criteria and has already been in use in other conservation disciplines for many years now. Because of its construction, air flow is possible through the weave of the textile. It is also possible to obtain polyester in widths up to 5m to reduce the need for seams, and with a napped surface to give an adhesive key for the subsequent layers.

In application, the polyester does not require the extreme tension of a canvas, as it is simply hung hand-tight with no need of a size to heighten and fix the tension. The consequent application of paper provides the further adequate tightening of the polyester. Non-rusting staples with a flat bar are used to avoid cutting when fastening the polyester.

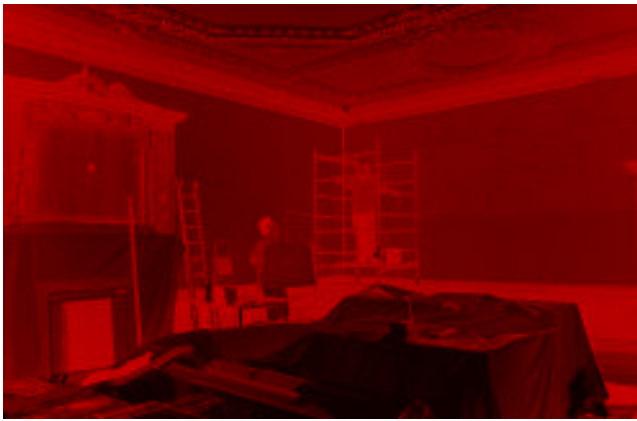
3. The first layer of Japanese paper being applied to the polyester textile.

As the synthetic polyester textile does not absorb moisture, the bond formed when adhering the first lining paper using a traditional starch paste is not as strong as that to a natural canvas. This however, is not necessarily problematical [2] and can be countered to a greater extent by careful selection of paper and slight modification of the adhesive. The addition of

5% v/v PVA to the wheat starch improves the bond, but more importantly, the choice of a Japanese paper that fibrillates easily to allow fibres to be worked in to the weave of the textile during application strengthens the bond [3].

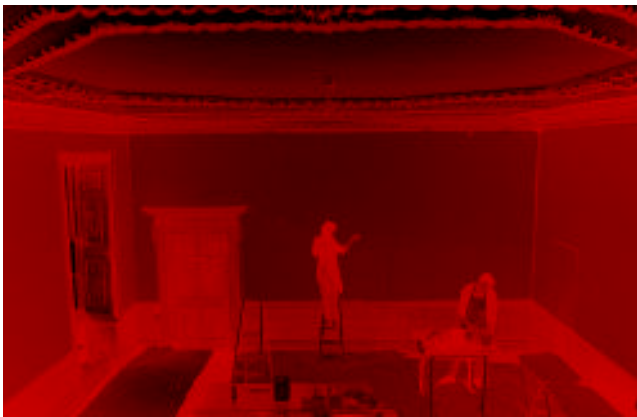
4. The Ukekake ('cushion' or 'pocket') layer being applied to the first layer of Japanese paper in quarter sheets.

The *ukekake* layer consists of quarter-sheets of Japanese paper, pasted along each edge to a depth of 3 to 5mm. The sheets overlap by about one quarter of the height and width of each sheet, the outermost having its exposed edges water-cut. When two *ukekake* layers are used, the paper is turned ninety degrees for equal distribution of grain direction. The artwork is then pasted directly onto this, except in the case of a very large object, such as wallpaper, when a sealing layer is first applied, again balancing the grain direction, *ukeshibari*. The *ukekake* layers act as a kind of cushion between the surface beneath, whether it is a traditional *shitabari* system or a layer of polyester. The network of pasted edges within the *shitabari* layer or layers distribute the tension of the artwork over the whole surface, keeping it in contact with the support layer beneath, but allowing for some movement, expansion and contraction.
