Water Damaged Books: Washing Intact and Air Drying—A Novel (?) Approach

Presented at the Book & Paper Group Session, AIC 27th Annual Meeting, June 8–13, 1999, St. Louis, Missouri. Received for publication Fall 2002.

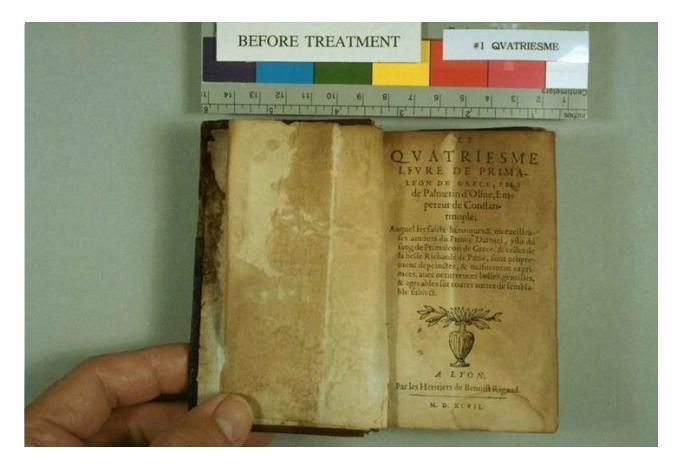
Fig. 1. Tidelines and brown stains in water-damaged book following freezing and vacuum freeze-drying

er, they also found multiple tidelines and severe brown stains, many of which seemed to be scorch-like in appearance (fig. 1). Since the leather covers were brittle, cracked, and chipped, I was asked to wash the books and rebind them. Of course, this would normally entail disbinding to wash the individual sheets, mending and guarding, as well as resewing before covering. However, since the sewing was intact on a majority of those books, I felt that this would be a good opportunity to reexamine washing a bound book. After discussing the concept, I suggested taking one volume for a trial test.

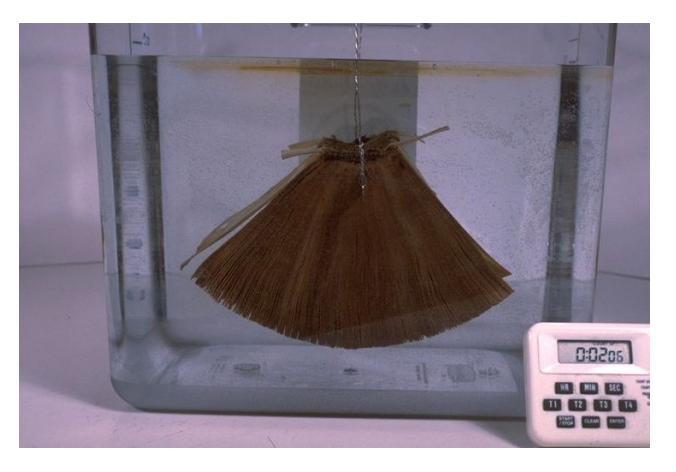
Fig. 2. Sewn text block fans out when suspended in the water bath

The basic procedure was to remove the covers and any loose leaves. The spine was cleaned using wheat paste and methyl cellulose. A hanger was made from a thin strip of stainless steel, .020 in. thick by 1/2 in. wide, that was suspended from a wooden dowel by stainless steel wire. The text block was opened to the center where it was hung on the strip. The text block was then slowly and carefully submerged in recalcified, deionized water. Upon immersion, the text block would wet and immediately began to fan out (fig 2). After a period of time, the water was drained and refreshed. Occasionally, the text block was gently lifted from the water to assist in the washing (fig. 3). When I felt that washing was complete, the water was replaced with magnesium bicarbonated water. After a half-hour bath in magnesium bicarbonate, the text block was removed from the hanger. It was then placed between two sheets of binder's board and reshaped, as well as pressed to remove the excess water. More water was removed by placing it in a lying press.

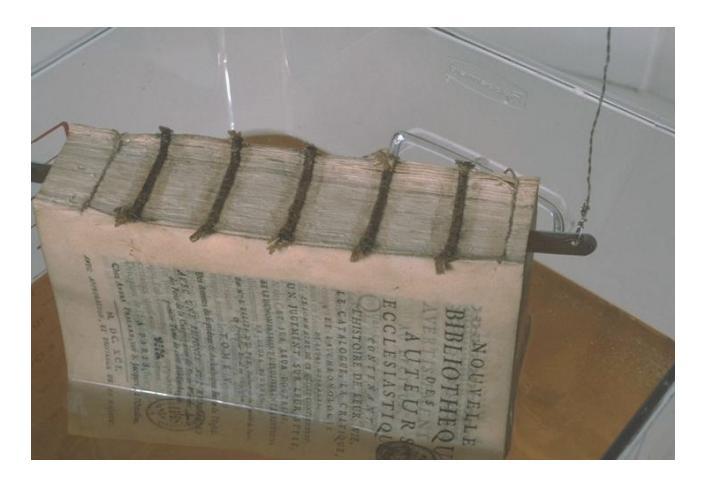
Fig. 3. Text block is gently lifted from the water bath

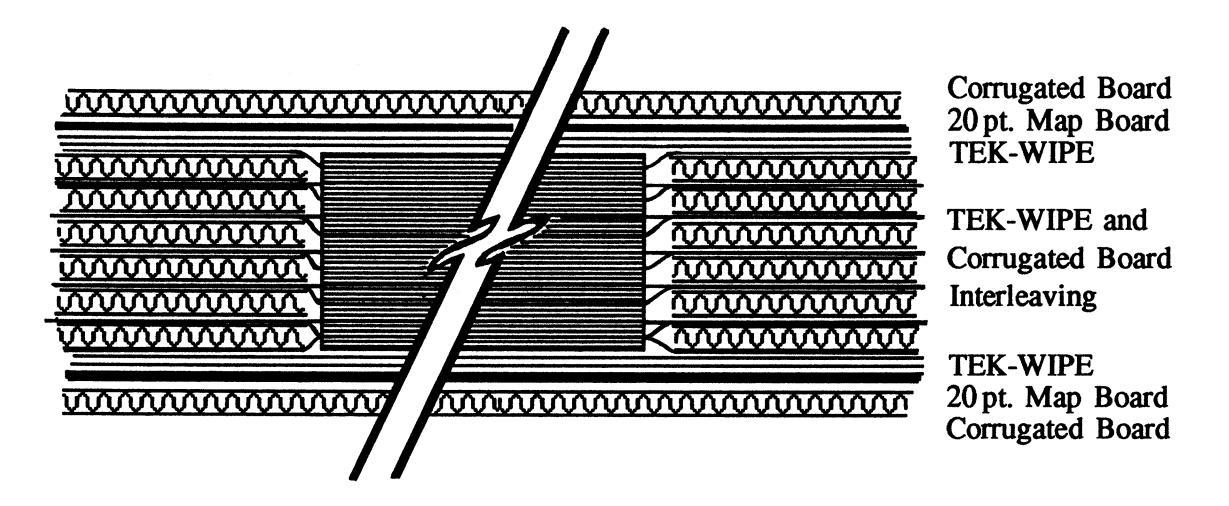
Fig. 4. Schematic of the drying stack (as viewed fore edge on). Flutes of the corrugated board all run perpendicular to the spine of the text block.

The books from the University were typically 5 in. x 8 in. in size, so the TEK-WIPE was cut to 8 in. x 16 in. A piece of this material was then inserted into the wet text block at intervals of about every eighth inch. The size of the material allowed for an overhang at the head and tail of about four inches. Some of the material also extended beyond the fore edge. Two extra pieces of TEK-WIPE were placed at the front and back of the text block. The fully interleaved text block was laid on a piece of 20-pt. map folder stock, as well as on an 8-in. by 16-in. piece of acidfree corrugated board with the flutes of corrugated board running perpendicular to the spine of the text block. With the text block interleaved, smaller pieces of corrugated board were inserted between the various extensions of the TEK-WIPE. At this point it needs to be emphasized that all of the flutes of the corrugated board are running perpendicular to the spine (fig . 4). One needs to use some judgment at this point because the corrugated tends to be thicker than the spacing of the interleaving. In other words, one piece of corrugated might be placed between two sheets of the TEK-WIPE (note: sometimes, we

removed the upper surface of the corrugated to assist with airflow, see figure 5). When the spaces are filled, another sheet of 20-pt. map folder and 8 in. x 16 in. corrugated were laid on top. The completed stack was now uniform in thickness. Since the spine was the most exposed portion of this block, I decided to add a moistened pad of cotton batting cut to size along that area. It was held in place by another piece of TEK-WIPE that was wrapped around the spine.

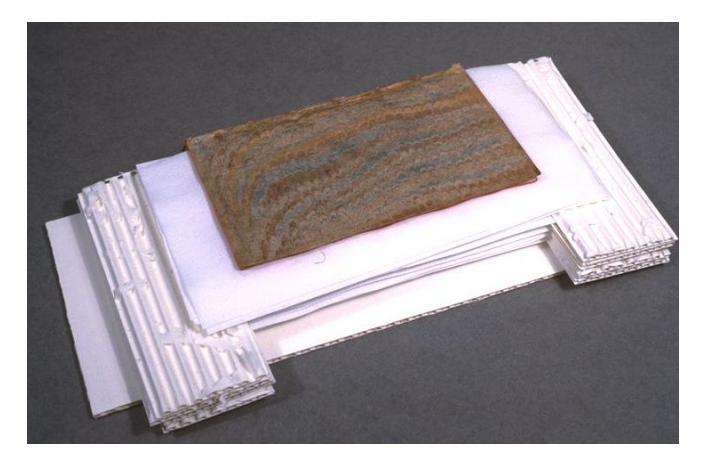
Fig. 5. Drying stack: the upper surface of the corrugated board has been removed to facilitate air flow

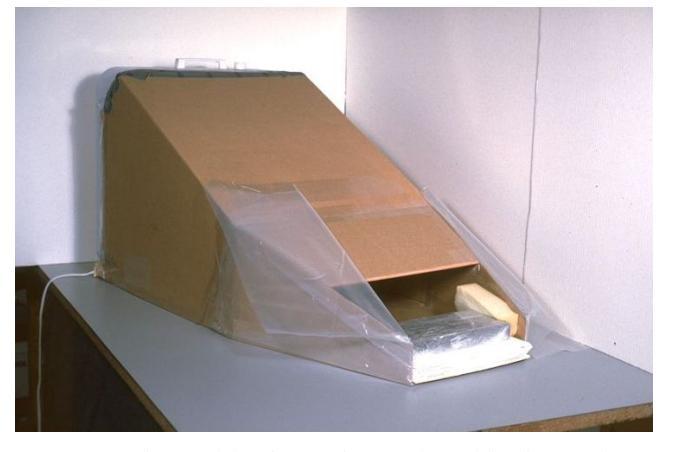
Fig. 6. Wind tunnel for drying the interleaved book. Box fan at the back is turned to *pull* air through.

Then the whole assemblage was placed in a sort of wind tunnel. This was constructed of corrugated board with a standard box-style window fan set into the end (fig. 6). The other end was somewhat smaller where the text block would be placed. The window fan was arranged to 'pull' the air through the tunnel and the corrugations, rather than trying to push the air. The fully interleaved text block was laid at the smaller end of the wind tunnel; a heavy

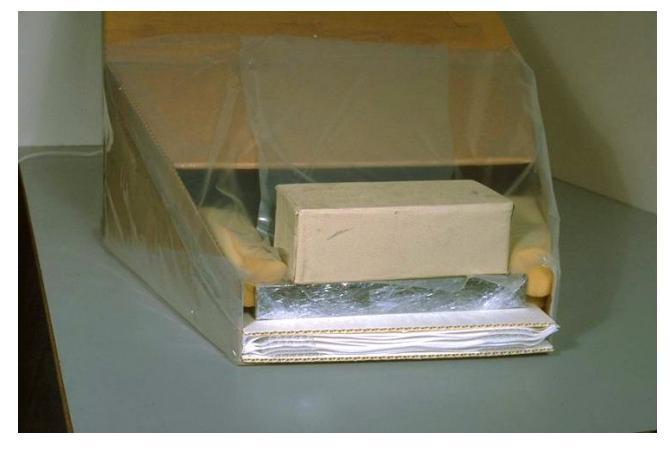
Fig. 7. Polythene sheeting and close-celled foam seal the wind tunnel around the book

weight about the size of the book was placed on top. Voids were stuffed with a soft, closed-cell foam and a sheet of polyethylene sheeting was used to seal the tunnel except where there was corrugated board (fig. 7). With the fan set on 'medium,' the text block would stay there until it was dry.

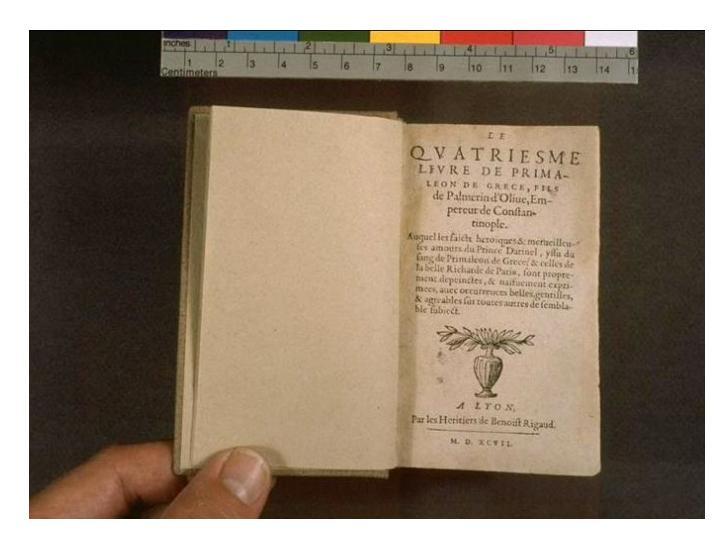
Fig. 8. Water-damaged book after treatment

To finish the books, we extended the existing cords with linen thread and new endsheets of handmade paper were sewn-on. Japanese paper and unbleached cotton muslin were attached to the spine. New boards were prepared and these were temporarily attached to the muslin. The book was then covered with a specially prepared cotton muslin. This fabric was sized with a 50/50 mixture of methyl cellulose and wheat paste, to which liquid acrylic artists' paints

had been added. This special cloth was easily molded over the raised bands. Upon completion, a gold stamped leather label was attached to the spine between the raised bands, and blind tooled lines were added. To enhance the appearance of the raised bands, black carbon-paper lines were tooled along the sides of the raised bands.

Due to cost and time constraints, only twenty-five of the more than 250 volumes were treated in this manner. The end result was a series of aesthetically pleasing books that were clean, stable, and useable, and bore minimal traces of their disastrous water damage (fig. 8). While these books were covered in cloth, they will be quite compatible with the leather bound volumes in the collection for the University of Maryland (fig. 9).

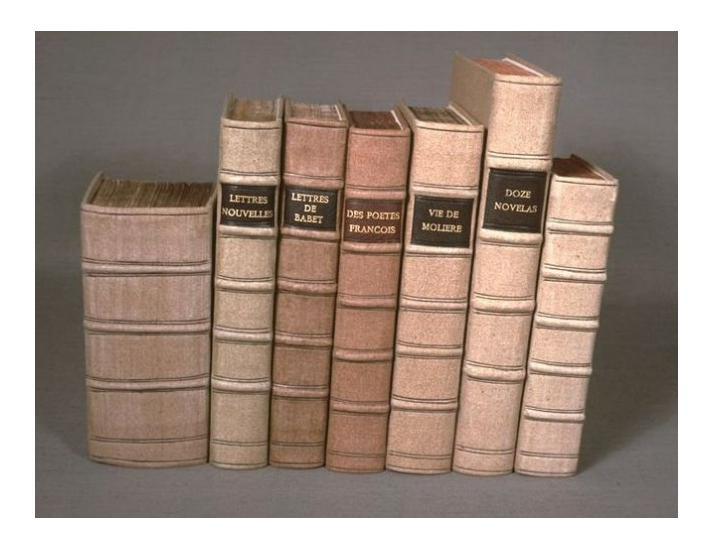
Fig. 9. Treated volumes rebound in cotton muslin
